RAILWAY INVESTIGATION REPORT

R04H0014

CROSSING COLLISION

CASTLEFORD, ONTARIO

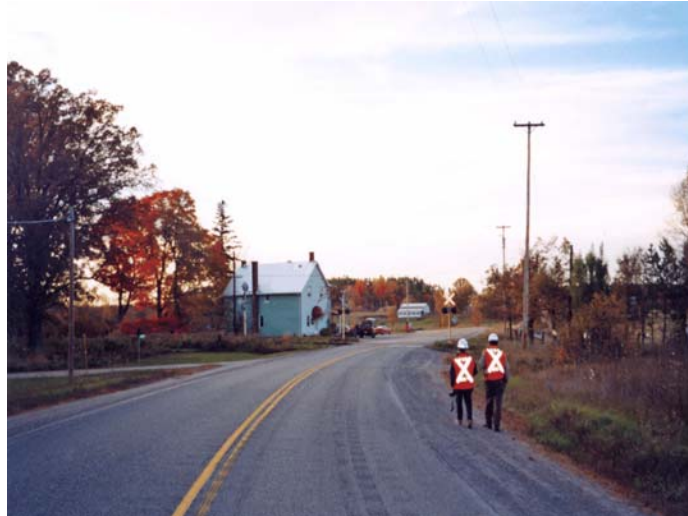
For northbound traffic on River Road, the view of the crossing signal warning lights was severely restricted by trees growing next to the highway on the highway right-of-way and on adjacent property, and by a right-hand horizontal curve. Because of the horizontal curve and its downward slope, the highway approaching the crossing is difficult to navigate at speeds higher than the speed limit. The 250 m radius curve met the province of Ontario's minimum geometric design standards for a highway design speed of 80 km/h. In Ontario, roadway design speeds are typically 20 km/h higher than the posted maximum operating speed.

Photo 1. Crossing approach from about 300 feet

It was determined that the distance at which the front crossing signal warning lights (right side) were focused and visible to the operator of an approaching vehicle was approximately 450 feet. A driver operating at the highway speed (80 km/h) would traverse the distance between the point at which the signal lights were visible (450 feet) and the actual crossing in 6.2 seconds. It was also determined that the mast and back signal warning lights (left side) were visible, but not conspicuous, from approximately 580 feet. A flashing light aspect was not visible from a range of 1000 feet because of a forested area on the inside of the curve approaching the crossing. The distance from the crossing at which an eastward train became visible from a northbound vehicle was 295 feet.

On 24 November 2004, and again in the fall of 2005, the road authority cut brush along the highway right-of-way, which was interfering with the sight-line to the crossing signals, but not on adjacent private property where there is growth that interferes with visibility of the signals. The road authority was not successful in its attempts to contact and make an official request to the owner of the private property adjacent to the highway to allow the road authority to remove trees and brush that interfere with the sight-line to the crossing signals.
